**Object ID:** 1993.1.1-57      **Conservation ID:** CL4.1993.1.1-57

**Title:** Section of Palace Facade

## Treatment Report

Surface dusting and minor stabilization

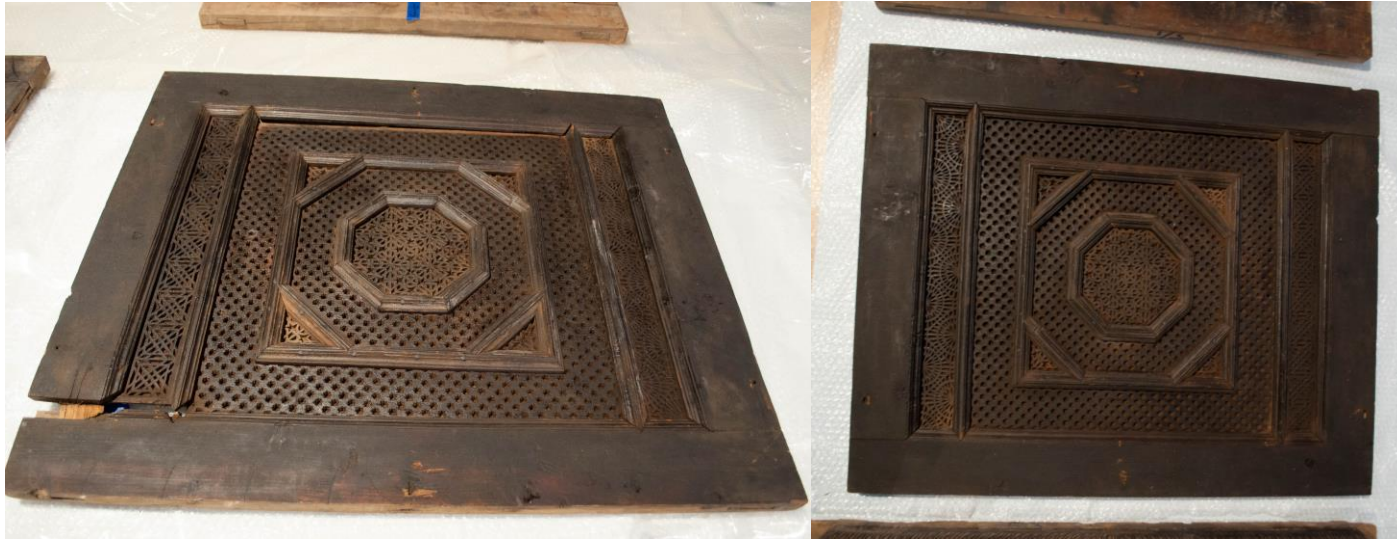
Section/ Acc. Number	Condition	Treatment	Notes
1993.1.5	Mortis and tenon joint separated in one corner, minor splits to tenon and pegs.  Crossbar at back lifted from board.	Split tenon joint stabilized with high tack fish glue and clamped into place.  Lifted crossbar stabilized with 50% Paraloid B72 in acetone bulked with micro balloons.

1931.1.5: Before treatment (left) with the broken mortis and tenon joint, and (right) after treatment
