Object ID: 1991.746A-E

Object Name: shadow puppet

Treatment Report

1991.746A-E, Thai Shadow Puppet – Condition Examination of the Verso

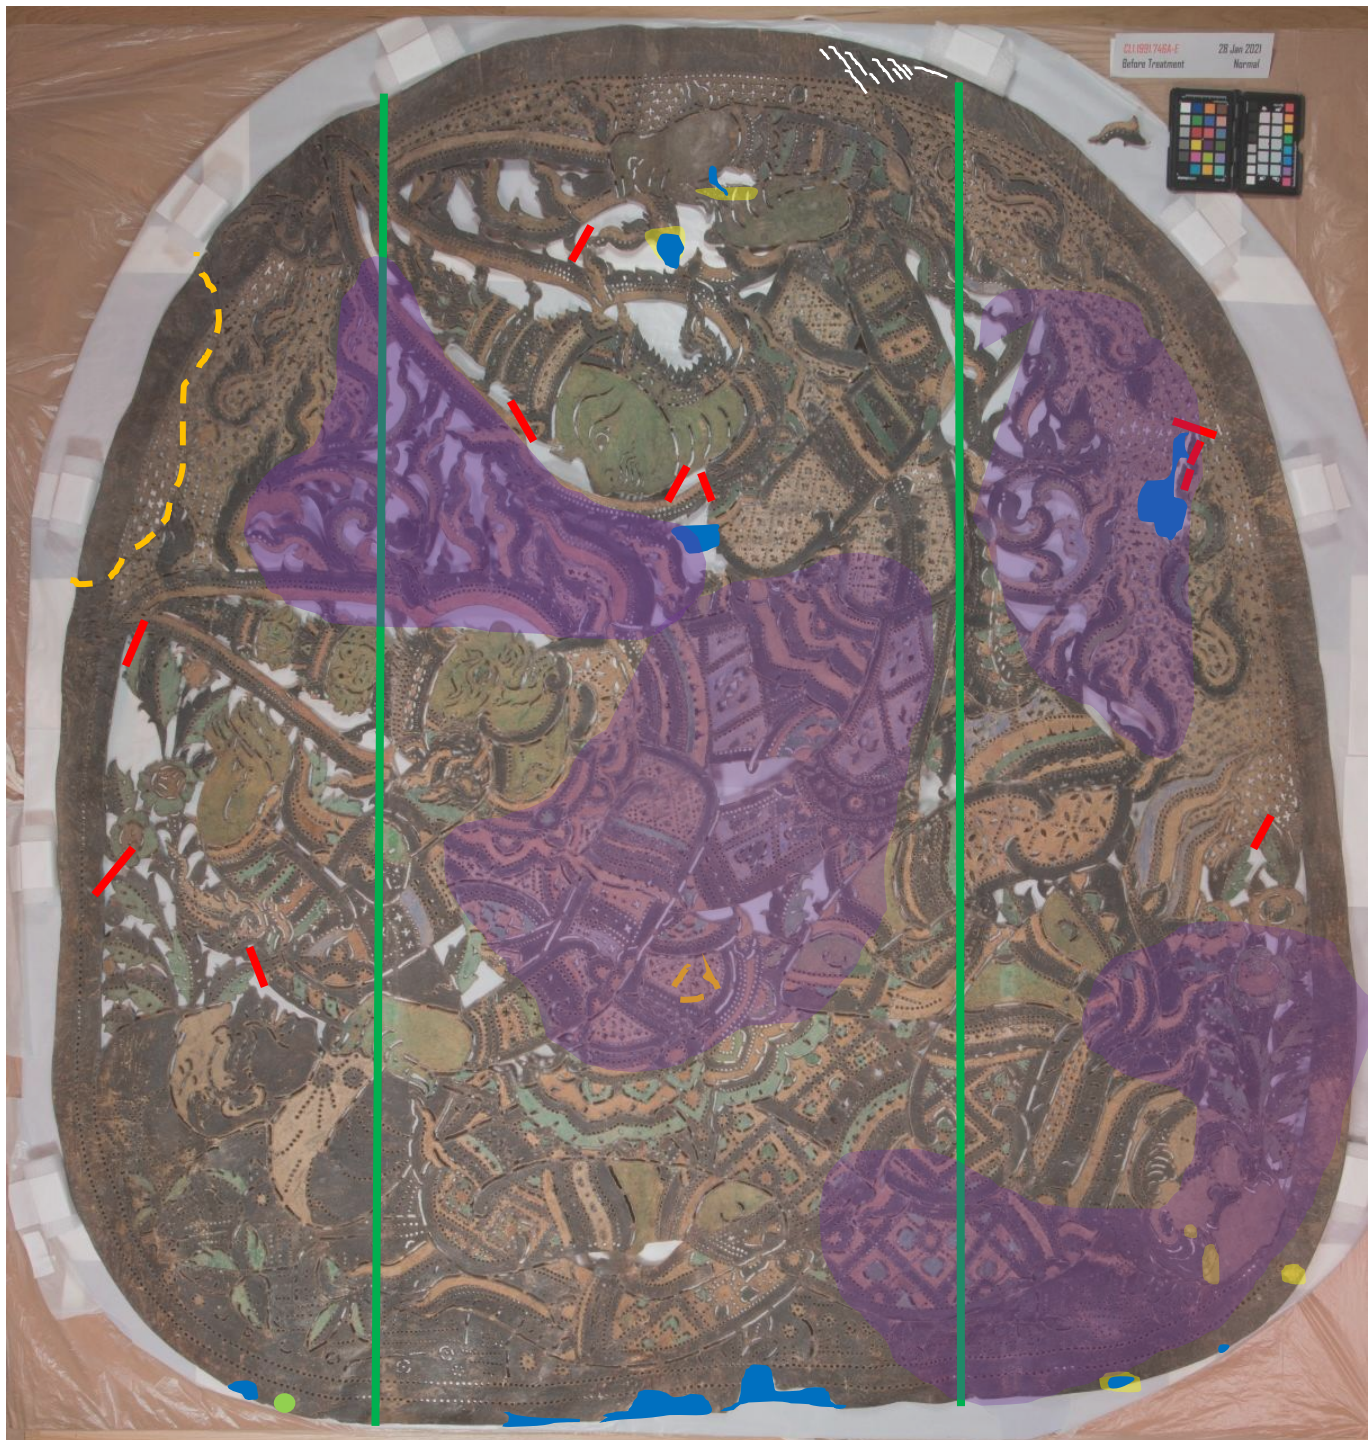
Before Treatment Condition Map
Front/Recto
1991.76A-E
Jan 22, 2021, EBrzezinski

There is a detached section of rawhide measuring approximately 3 inches long which may have come from Rama's proper right shoulder or the punchwork on the proper left side.

There are several losses. The most significant of these occur around Rama's hands, the leaves at the proper right side, and in the punchwork at the proper right side. There are scalloped shaped losses to the bottom edge ranging from 1x1 inch to 2x4 inch in size. It is unclear if these areas have been cut, are due to the shape of the original hide, or are from fabrication or use.

The rawhide is extremely brittle and exhibits significant deformations and buckling overall. The area around Rama's face, Rama's lower body, and one of the fallen figures on the lower proper left side exhibit the most severe deformations.

There is a crescent-shaped seam at the proper right side approximately 18 inches long that attaches a smaller section to the main section of rawhide. Another circular seam is located at Ravana's waist, approximately 20 inches from the proper right edge and measuring 1 inch in diameter. In both instances, the wear, surface patina, and pigmentation of the attached section and seam appear similar to the rest of the surface, suggesting the repair is either from fabrication or when the puppet was still in use.

The rawhide exhibits overall abrasion and wear. White abrasions are present along the top border. There is a glossy accretion on the lower proper right corner.

Several areas of heavier abrasion to the rawhide surface appear similar to insect damage. However, this type of abrasion is not consistent, and no active signs of insect infestation were noted.

There are two vertical lines across the surface characterized by abrasions, pigmentation variations, and minor deformation, which may indicate where the wooden poles were placed during the puppet's use. Each begin at the bottom edge and run vertically through the composition for approximately 39 inches. These "stripes" exhibit brighter pigment, lines of parallel abrasion, a slight indent into the rawhide, and the appearance of water damage.
