Conservation ID: CL4.1993.1.1-57

Object Synopsis: facade | palace | Section of Palace Facade | Islamic | Pakistan | wood | metal | c. 1835 | TL-13359

Purpose: Assessment and treatment for installation

Type of Record: Treatment

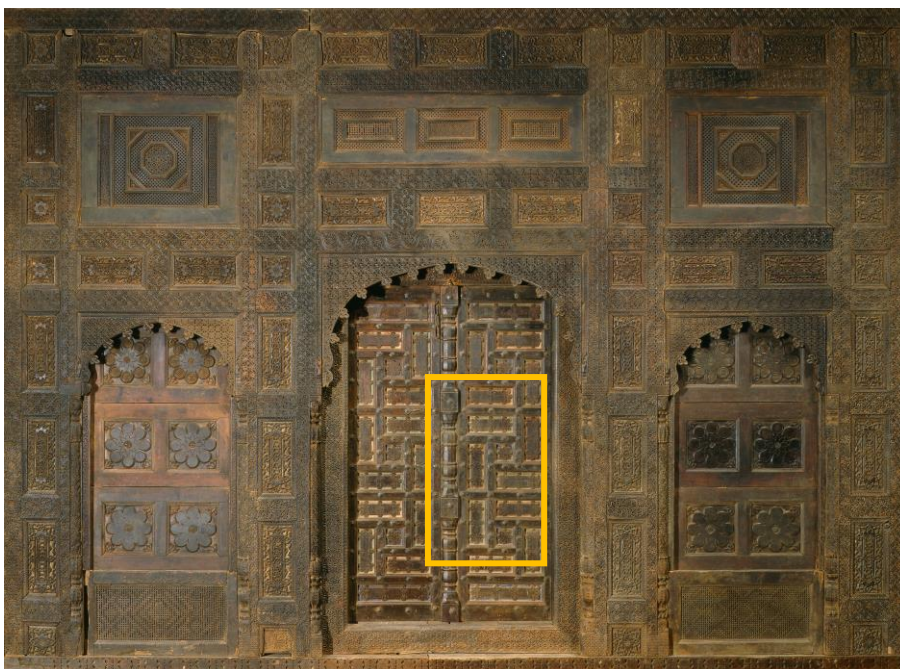
Sample 1: (Fig 1-2) thin, white, waxy bloom present over much of the surface, taken from the front interior edge of the proper right door (1993.1.14b), sent in vial

Fig 1: Overall view of the façade installed, Fig 2 (below, with sample 1 area) shown in yellow square

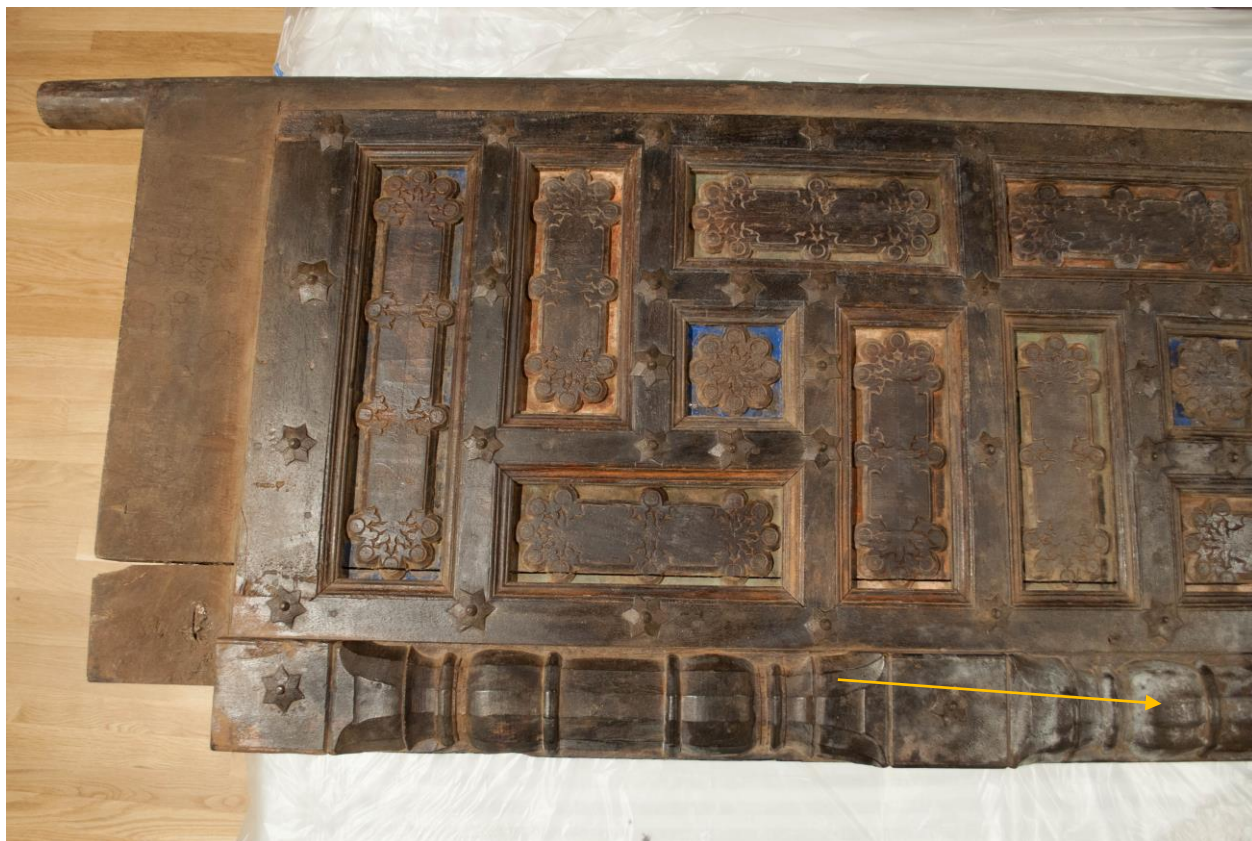
Many sections exhibit an unknown bloom that appears white, thin, and has a slightly slick or waxy feel. It occurs on the carved face of the sections, more commonly in the carved recesses and darker, more saturated areas. It is generally minimal and irregularly distributed but appears heavily on several sections (noted in the attached treatment document), most notably the interior edge of the door.

Fig 2: Detail of proper right door 1993.1.14b. Location of Sample 1 shown in yellow arrow

- Areas of heavy bloom were cleaned a second time with a worn toothbrush and vacuum until the bloom was removed.

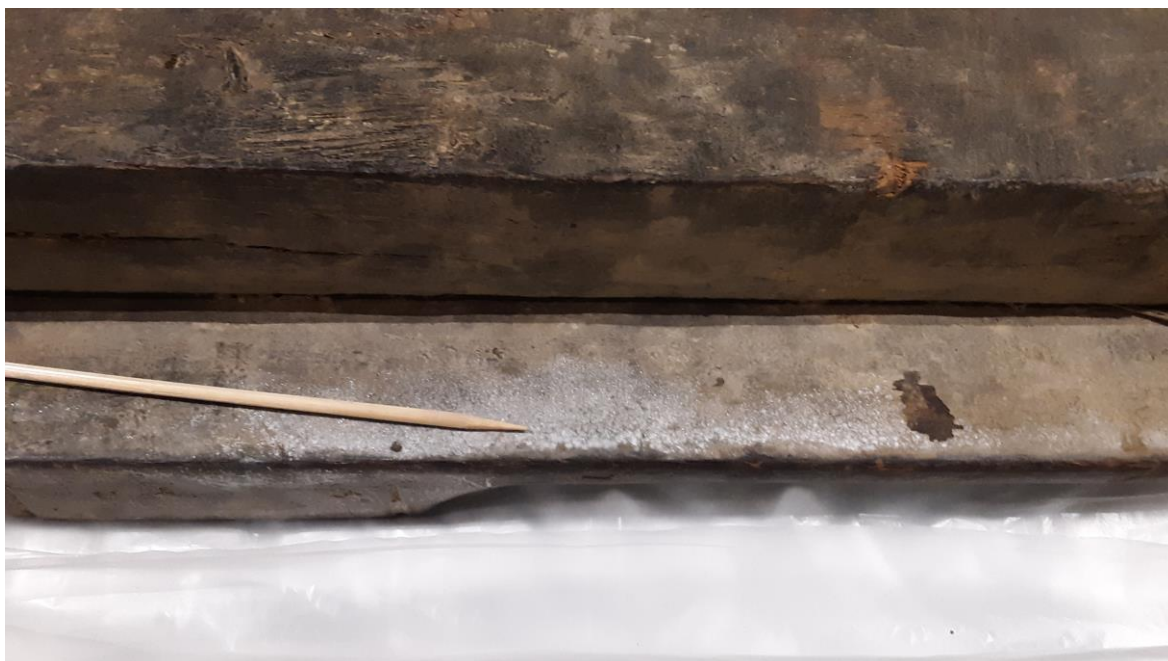
Date: 4/14/2021 12:00:00AM
Type of Analysis: Fourier Transform Infrared Spectroscopy (FTIR) X-Ray Diffraction (XRD)
Sample Used: Sample 2
Results/Notes: FTIR identified a good match with palmitic acid, a common saturated fatty acid found in plants, animals, and microorganisms. It is the major ingredient in palm oil.

Sample 2: (Fig 3), thicker, white, fluffy rather than waxy bloom, taken from the back of the proper right door's interior edge. Had a different consistency than bloom on the rest of the surface, but possibly just a heavier area and same material as Sample 1. Sent in slides.

Fig. 3 Underside of proper right door 1993.1.14b. Location of Sample 2 shown with skewer
