**Object ID:** 1993.1.1-57      **Conservation ID:** CL4.1993.1.1-57

**Title:** Section of Palace Facade

## Treatment Report

Surface dusting and minor stabilization

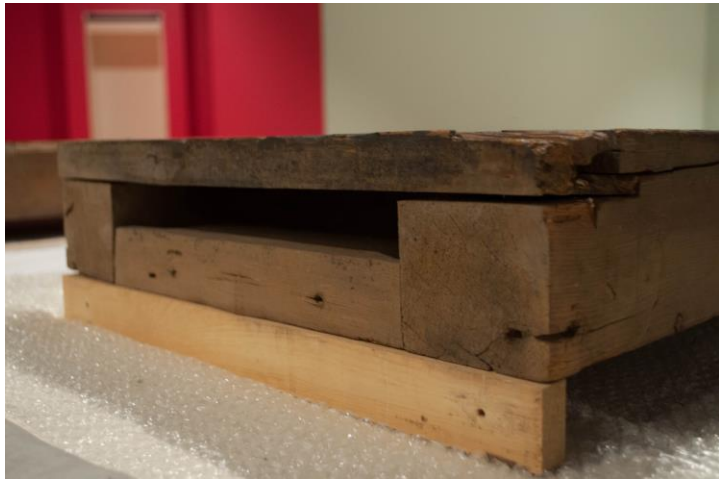
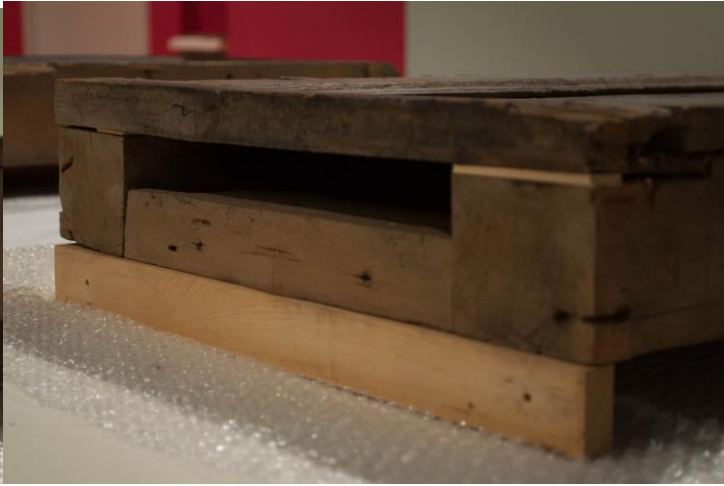
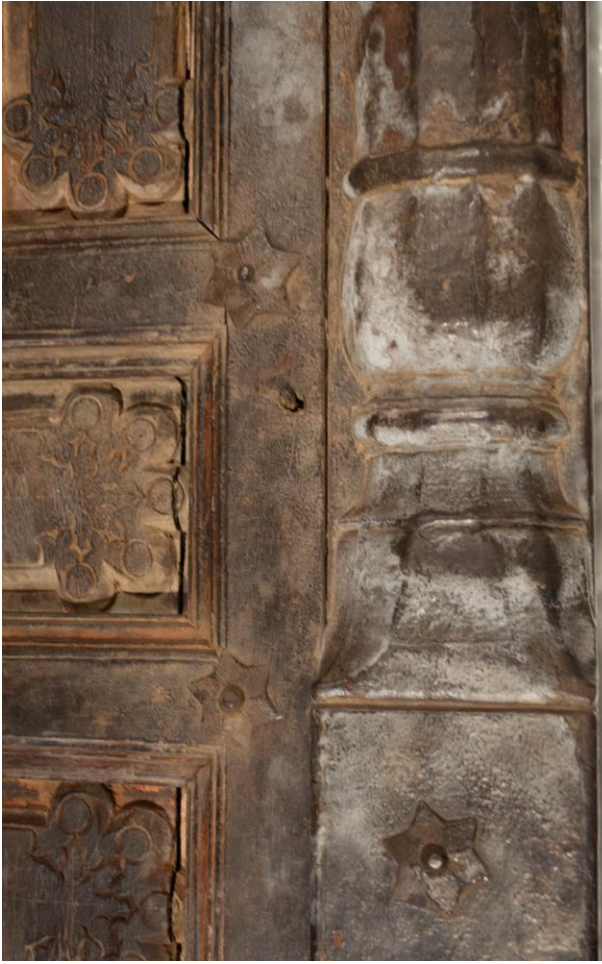
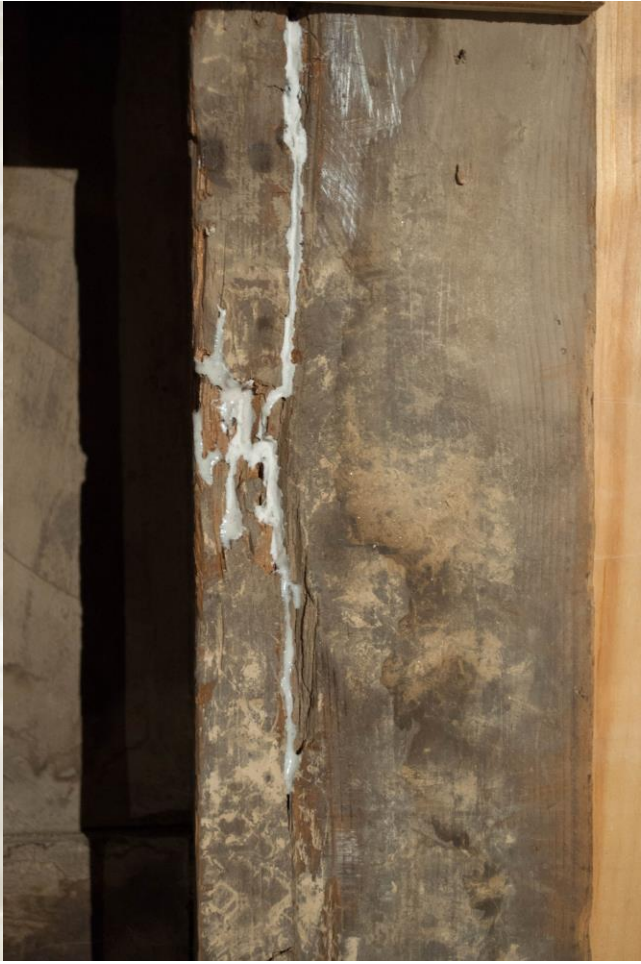
Section/ Acc. Number	Condition	Treatment	Notes
1993.1.5	Mortis and tenon joint separated in one corner, minor splits to tenon and pegs.  Crossbar at back lifted from board.	Split tenon joint stabilized with high tack fish glue and clamped into place.  Lifted crossbar stabilized with 50% Paraloid B72 in acetone bulked with micro balloons.

1931.1.5: Before treatment (left) with the broken mortis and tenon joint, and (right) after treatment

- Two sections required more involved stabilization, including repair to the mortis and tenon join of 1993.1.5, and shims to stabilize the cross member of 1993.1.22. Details are given in the attached document.
