Conservation ID: CL4.1993.1.1-57

Object Synopsis: facade | palace | Section of Palace Facade | Islamic | Pakistan | wood | metal | c. 1835 | TL-13359

Purpose: Assessment and treatment for installation

Type of Record: Treatment

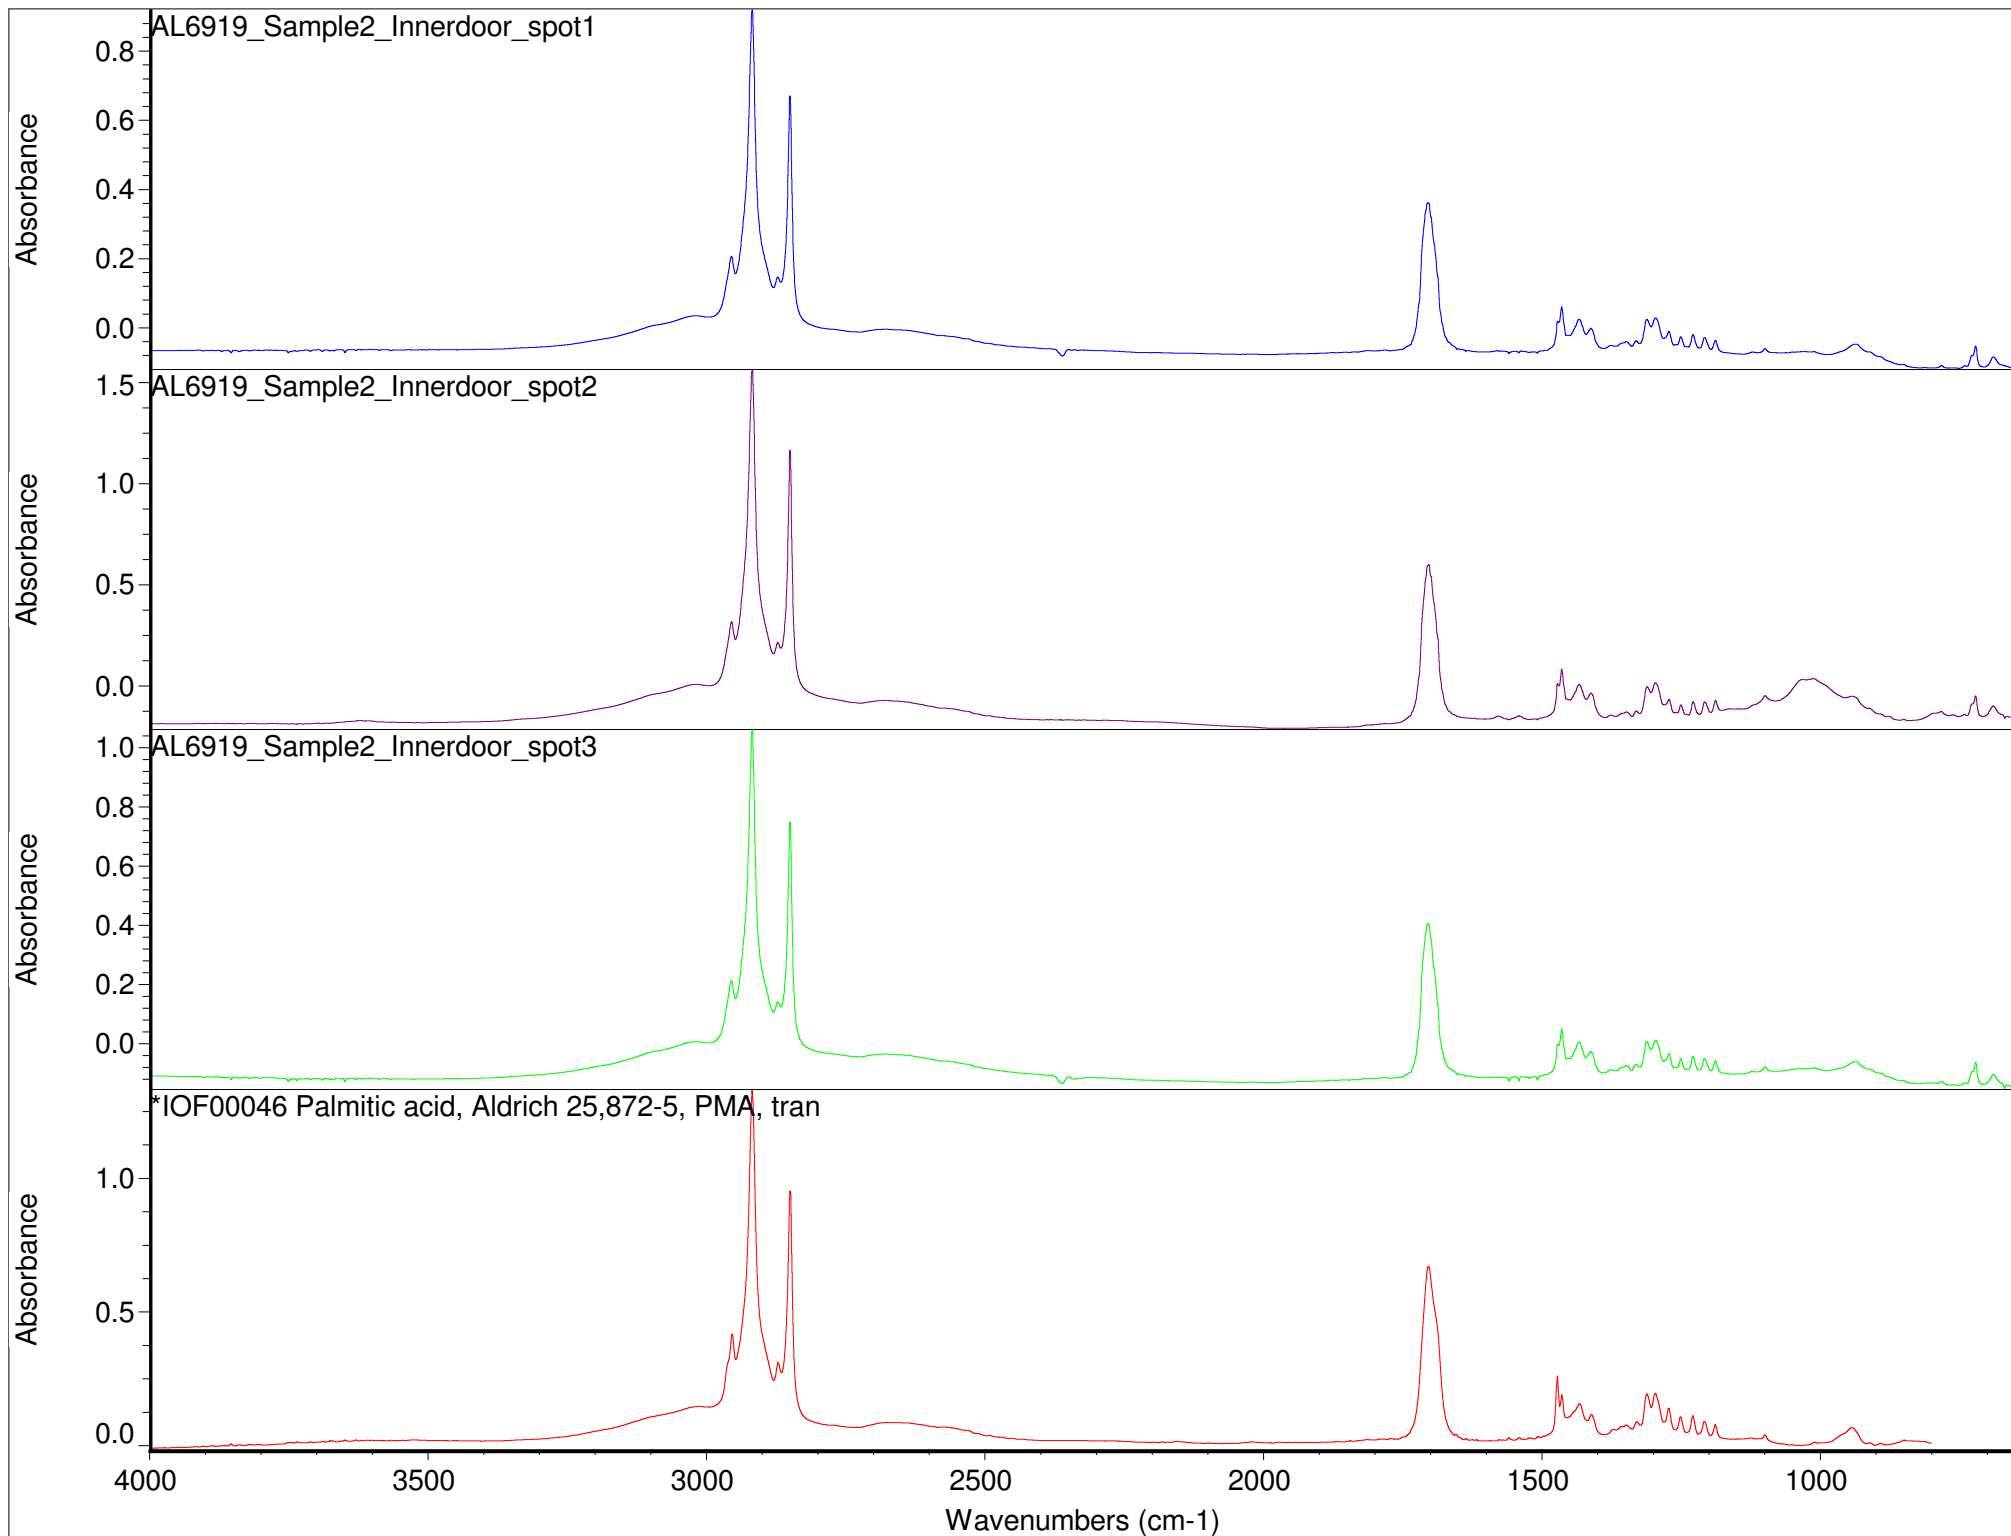
Date: 4/14/2021 12:00:00AM
Type of Analysis: Fourier Transform Infrared Spectroscopy (FTIR) X-Ray Diffraction (XRD)
Sample Used: Sample 2
Results/Notes: FTIR identified a good match with palmitic acid, a common saturated fatty acid found in plants, animals, and microorganisms. It is the major ingredient in palm oil.

Sample 2: (Fig 3), thicker, white, fluffy rather than waxy bloom, taken from the back of the proper right door's interior edge. Had a different consistency than bloom on the rest of the surface, but possibly just a heavier area and same material as Sample 1. Sent in slides.

Fig. 3 Underside of proper right door 1993.1.14b. Location of Sample 2 shown with skewer
